FOUNTAIN CREEK REACH 7

AQUATIC RESTORATION PLAN NARRATIVE

Aquatic Assessment  
&  
Habitat Enhancement Plan  
Fountain Creek - Memorial and Mansions Park  
City of Manitou Springs  
El Paso County - Colorado

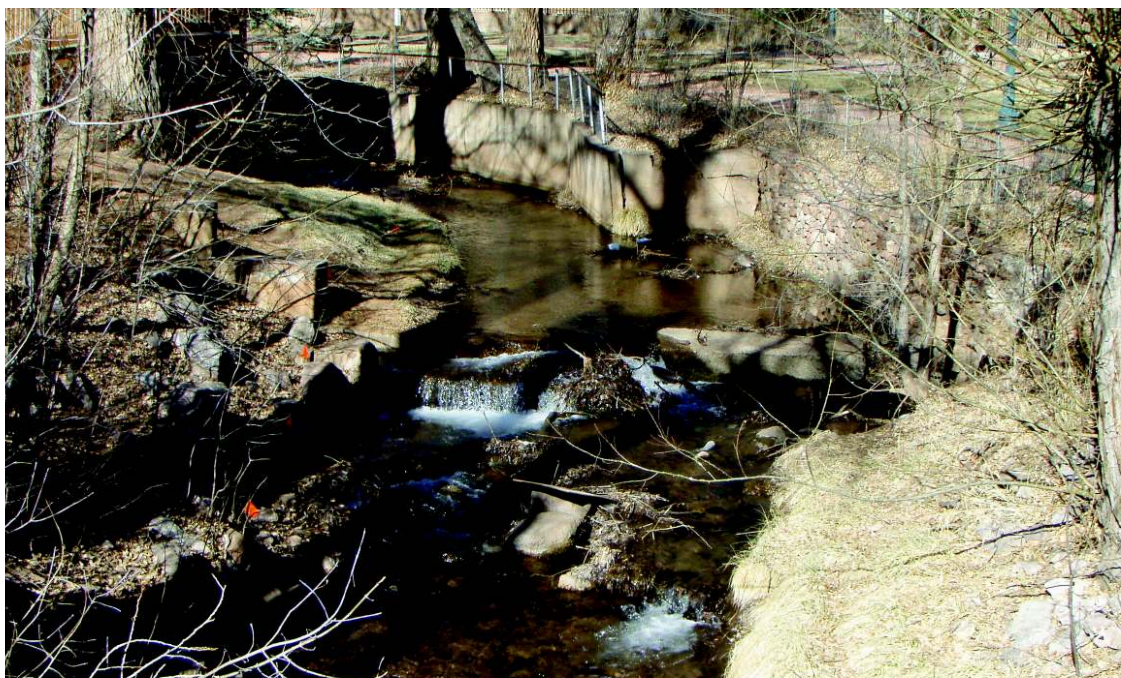
Photo 3: Concrete block drop structure - Mansions Park behind City Hall.

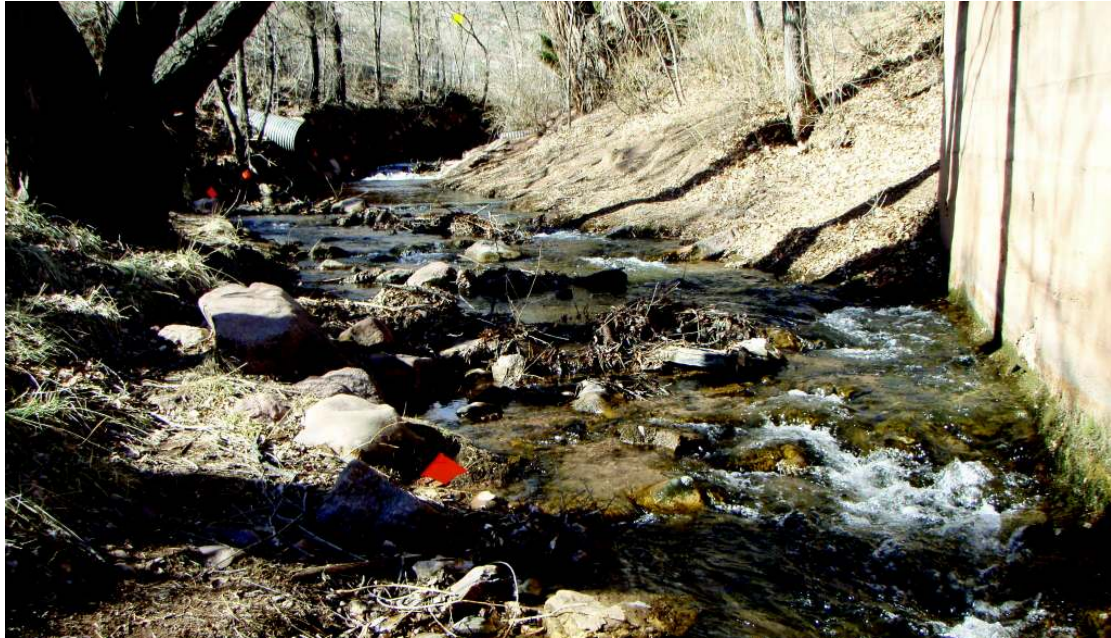
Photo 4: Lower half of Memorial and Mansions Park project reach, looking upstream.

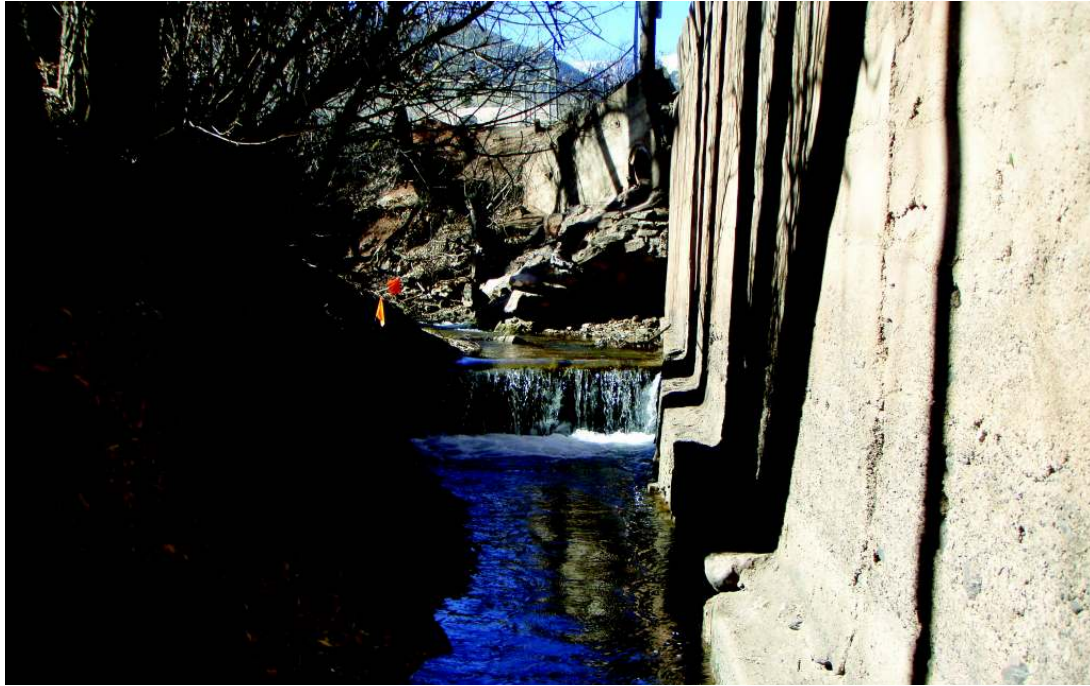
Photo 5: Upper barrier adjacent to Lover's Lane – Fountain Creek Reach 7.

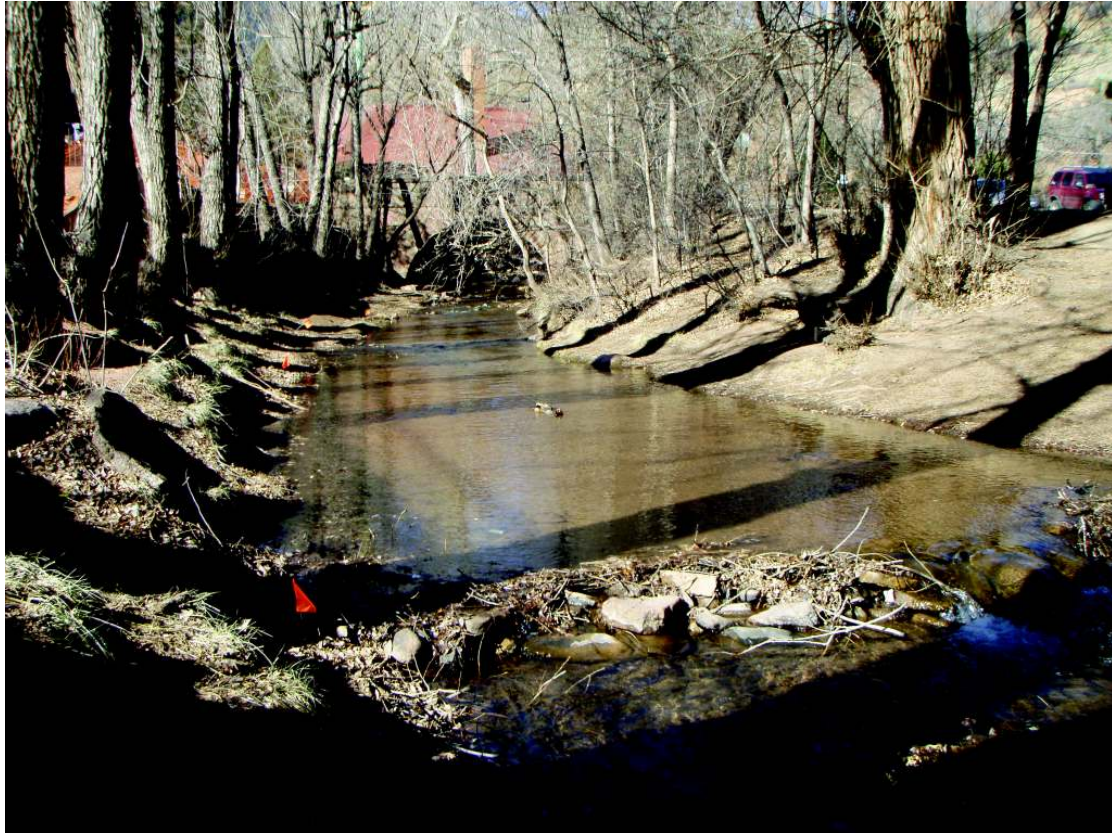
Photo 6: Over-wide glide habitat resulting from an un-authorized hand made dam structure along the Memorial Park segment of Reach 7.

A considerable number of glides were observed, comprising 20% of the reach. Glide habitat appeared to be the result of excessive sediment inputs upstream. Most of the glide habitats observed appeared to be former pools that had been completely in-filled with gravel and smaller diameter materials. Cover for trout was extremely limited in these habitats, which are characterized by laminar flow profiles and tend to provide little velocity shelter or protection from predators. Aggradation of sediment in the glides is resulting in a gradual over-widening of the bank full channel in these meso habitat forms. The average width of the glides observed in Reach 7 was 13.5 feet.

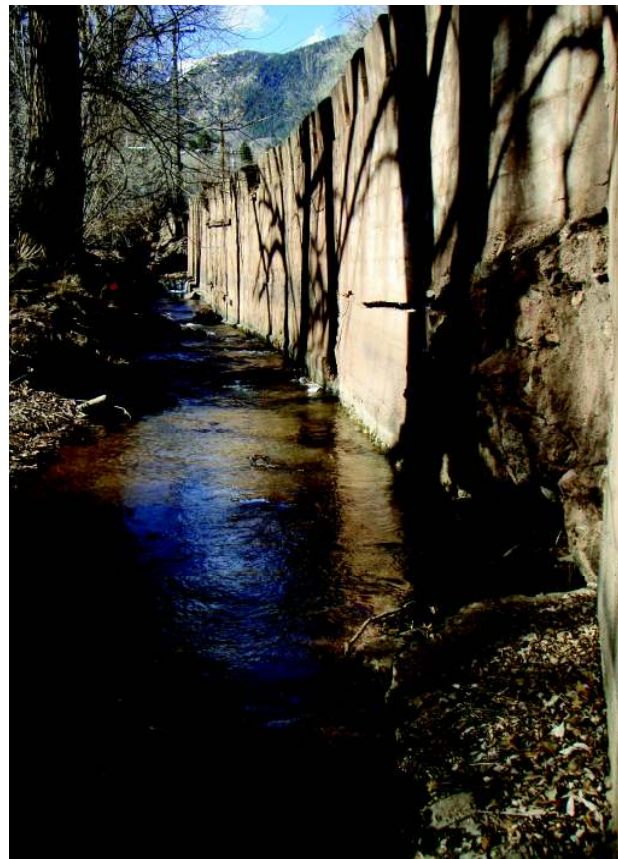
Photo 7: Unusual combination cover formed by failing concrete retaining wall footings - Lover's Lane retaining wall - Reach 7.

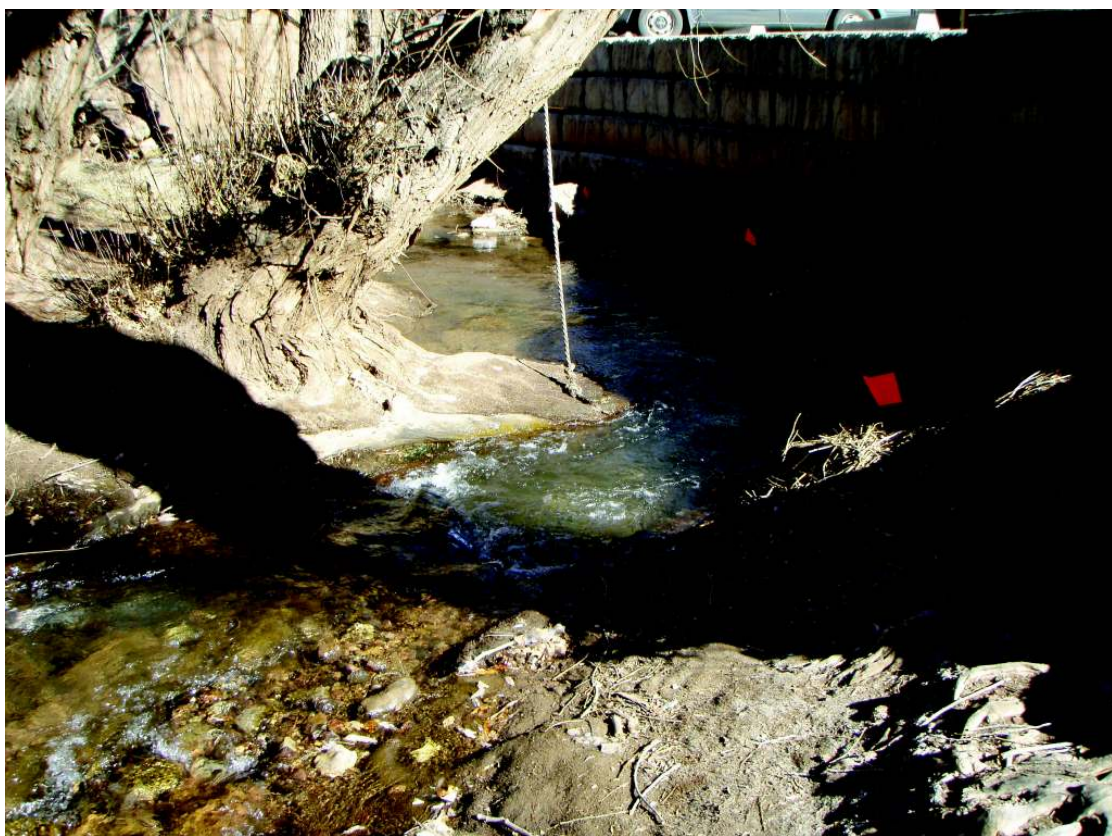
Photo 8: Two trench pools (Pool #15 and Pool #16) formed by a large cottonwood tree forming a constriction in the channel near the upstream boundary of Reach 7. Both of these pools exhibited efficient scour of sediment, acceptable residual pool depths, and maximum pool depth in excess of 1.5 feet.

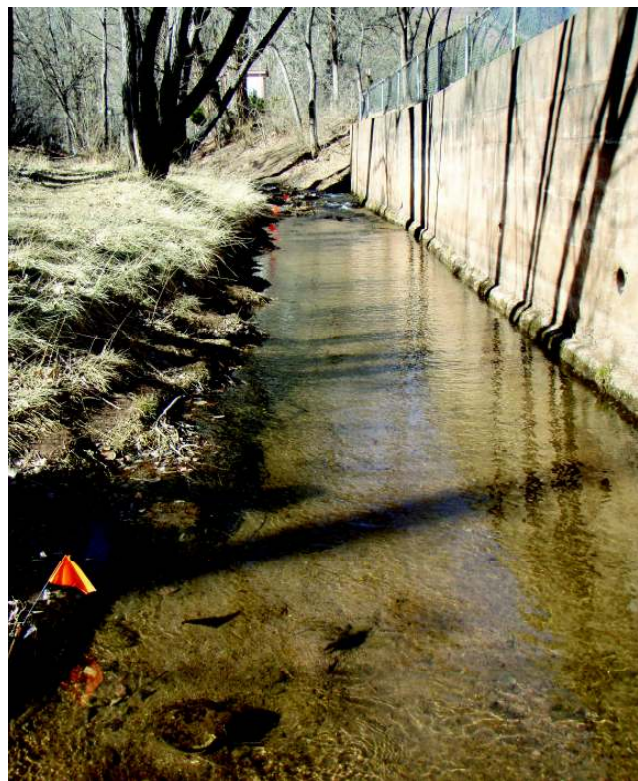
Photo 10: Glide 1, Pool 2, and Riffle 2 on Reach 7, looking upstream.

Approximately 100 feet of the right stream bank, from the end of the retaining wall at Riffle 2 to Riffle 5 will be re-vegetated using volunteers from the Rocky Mountain Field Institute. Several stone retaining walls will need to be constructed in the area adjacent to the pump house, in order to provide a stable terrace for vegetation to take hold. The existing 30 ft segment of boulder rip-rap on

the left bank of Pool 3 will be re-aligned in order to provide velocity shelter for trout as well as bank armoring and protection from shear. The existing creek access trail on the left bank will be repaired, with stone steps leading down to Pool 3. Additionally, a new stone stairway will be constructed on the right bank leading to the stream, immediately downstream of the pump house.

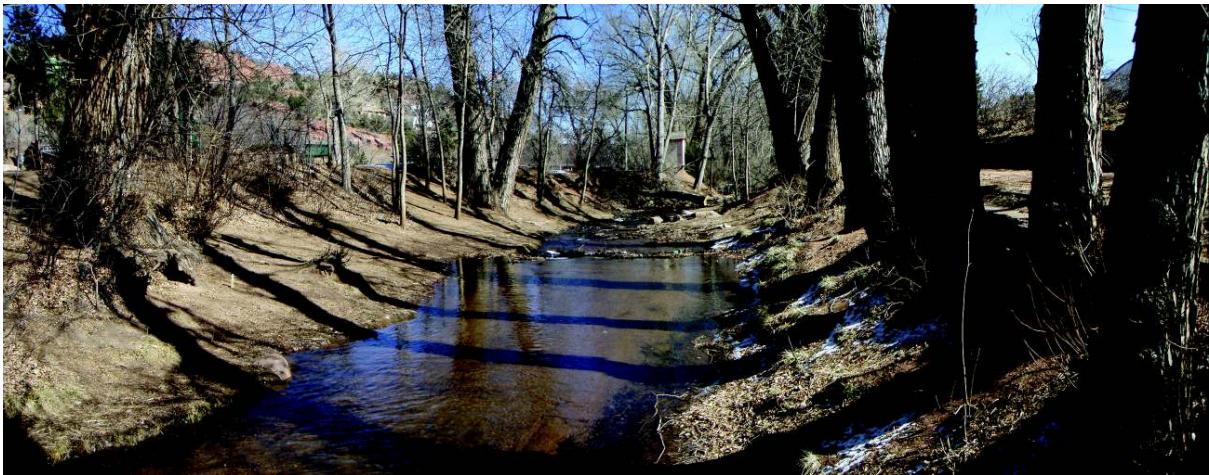
Photo 11: Over-wide segment of Fountain Creek in Memorial Park, looking downstream.

Upstream of the pump-house, the stream begins to exhibit excessive over-widening, due to sedimentation, bank damage from heavy recreational use, and the construction of an un-authorized dam perpendicular to the direction of flow that has resulted in bank failure and lateral migration of the channel. This hand constructed dam will be removed from the channel, and a large boulder cross-vane will be installed at Pool 5 to significantly improve the scour and depth of the pool and downstream glide habitat. The stream channel throughout this segment will be narrowed and re-defined using large wood toe-slope structures and bank-full riparian benches on both sides of the stream to reduce the width/depth ratio of the channel and improve sediment transport within the segment. The target bank-full width of the new channel will be 22 feet. Additional sinuosity will be built into this segment by building a slight meander into the newly defined channel. A total of 300 feet of these treatments will be necessary, split approximately evenly on each side of the channel. Narrowing the channel and improving sediment transport through this segment will allow us to increase and improve pocket water habitats within the riffles by adjusting the elevations and facet slopes of existing boulders in the riffles, and by adding additional boulder micro-vortex structures in appropriate locations throughout these riffle habitats. Up to twelve of these features may be added to Riffles 7 & 8.

Stream banks in this segment exhibit the same instability and lack of vegetation as the banks in Soda Springs Park (Reach 11), and similar treatments will be used to restore and revegetate the banks. In addition to the log/boulder toe-slope treatments to narrow and define the meander in this segment, several low stone walls/terraces will be constructed to alter and vary the slope of the bare banks leading to the stream and allow for re-vegetation with native riparian and upland plant species. All stream bank re-vegetation treatments will be coordinated with the Rocky Mountain Field Institute.

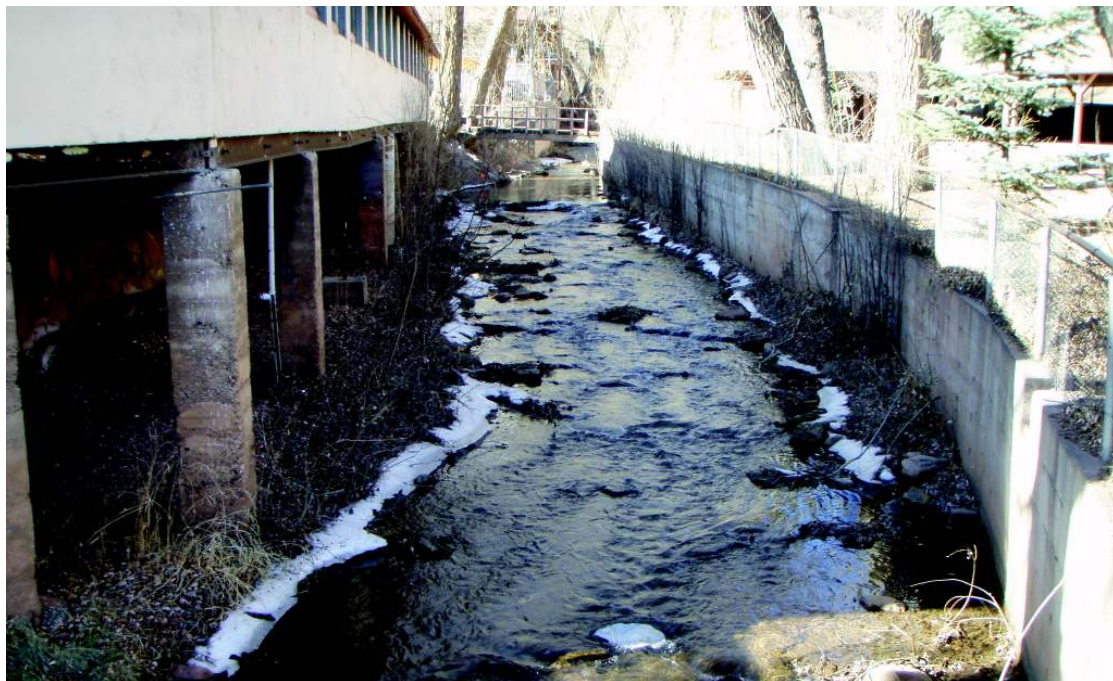
Riffle 12, Pool 8, and Glide 9 are confined by a concrete retaining wall on the north bank, and by the foundation walls of Manitou Springs City Hall on the south. The City Hall building overhangs the creek by 10 feet throughout this segment (see Cross-Section 5). Periodic high flows have begun to undermine a significant section of the building foundation on the north east corner of the building, and if not quickly addressed, could result in undesirable structural changes to the building. A thin line of riparian alder and

Photo 14: Fountain Creek adjacent to City Hall, looking upstream. The eroding foundation can be seen on the left side of the photograph.

willow has become established between the creek and the edge of the building, and we would like to further enhance this protective feature by installing log/boulder toe slope structures and riparian bank full benches along the entire south stream bank adjacent to the building. Behind these bank full bench features, boulder vanes may be installed underneath the building, extending at an angle of no greater than 30 degrees, from the foundation wall upstream to the concrete columns supporting the outer edge of the building. The spaces between these vanes could then be filled with smaller 8" – 12" rip-rap by the volunteer hand crews organized by the Rocky Mountain Field Institute.

The installation of bank full benches along the edge of the City Hall building will slightly reduce the width of the channel throughout this segment, which will, in term, allow us to further enhance in-channel aquatic habitat through this segment. Existing boulders in Riffle 12 will be adjusted to improve pocket scour and velocity shelter. These features, combined with occasional under-cut bank features built into the bank toe slope structures will significantly increase cover and holding areas in this marginal riffle habitat. In addition to the pocket water features, a boulder cross-vane will be installed at Pool 8 to improve depth and scour, and to direct the thalweg away from the building foundations downstream of this point.

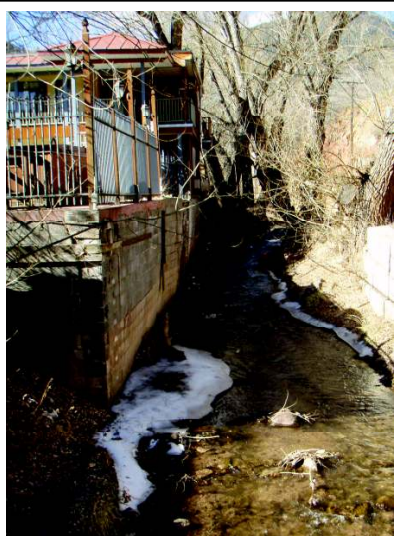
Photo 15: Pikes Peak Inn

appear to be in perilous condition, and might fail in a significant flood event, blocking the channel with debris and subsequently causing greater flood damage downstream. We recommend that the City contact the owners of the Pikes Peak Inn, and work with them to repair or remove this wall.

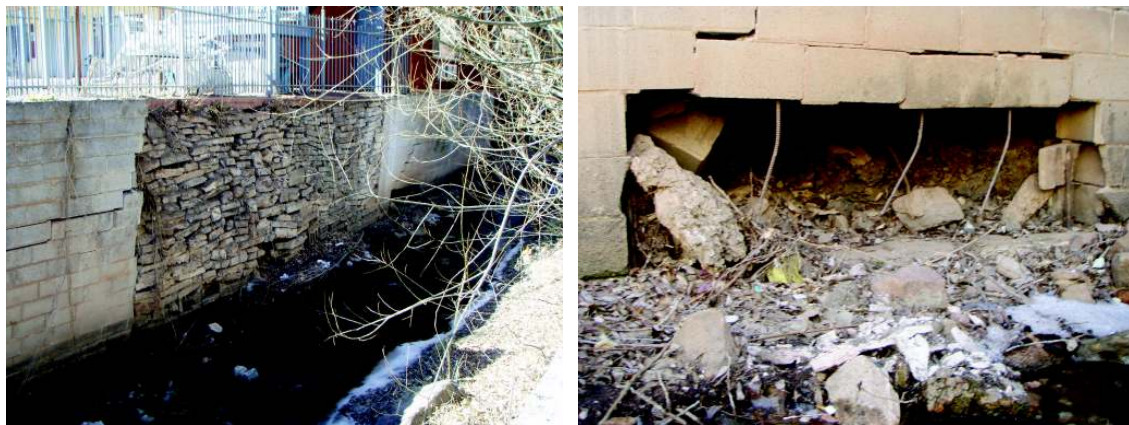
Photos 16 & 17: Failing retaining walls at the Pikes Peak Inn, within Sub Reach 7c.

While it is beyond the scope of this assessment to address these significant flood risk issues, there may be some relatively simple measures that could be taken to reduce the risk of catastrophic flood/breach/flood events in this segment. We would recommend that the City consider permanently closing and removing Lover's Lane from a point beginning at west side of Mansions Park on the east and the Wichita Parking lot

on the west. Removing both the road and the retaining wall on the north side of the stream would effectively increase the cross-sectional area of the stream channel through this confined segment, increasing the capacity of the channel to pass flood flows and debris with a lesser risk of debris damming and breaching. Creating a small bank full flood-plain on the north side of the creek at this point would allow for the Creek Walk trail to be constructed on this side of the stream. This strategy also has the advantage of not requiring the removal of any buildings or otherwise affecting private property. While this work is well beyond the scope of the Fountain Creek Restoration Committee and the aquatic habitat projects described herein, this might be a viable project to present to the newly formed Fountain Creek Watershed, Flood Control and Greenway District for assistance in development and funding.

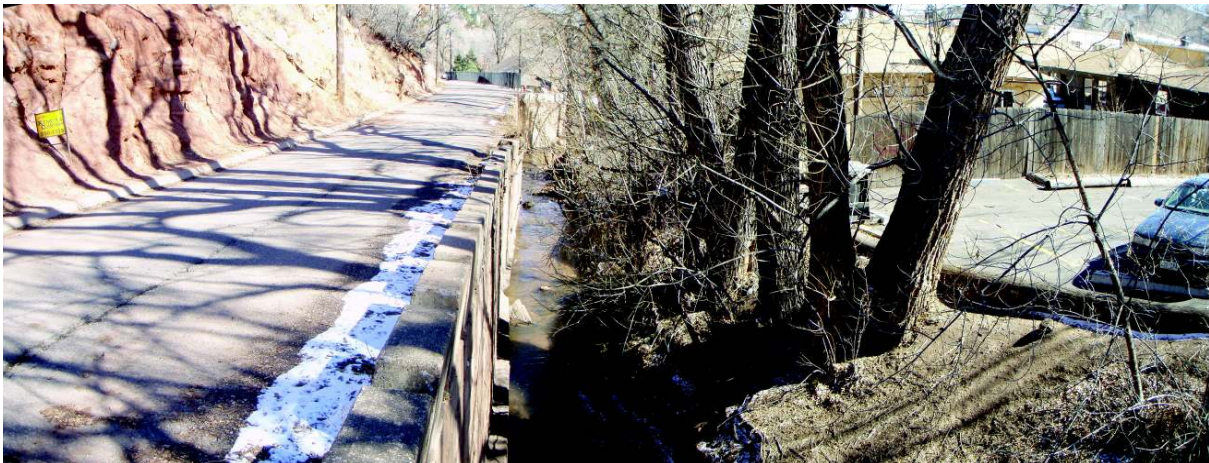
Photo 18: The severely confined segment of Fountain Creek adjacent to Lover's Lane.

In the interim, some minor hand work may be done in this segment with volunteer hand crews to stabilize the left (south) stream bank, particularly where the river has undermined the root systems of several large cottonwood trees. Boulders will be lowered into the channel from Lover's Lane using an excavator, and these will be positioned by hand crews along the left bank adjacent to these trees to reduce further undercutting of the root systems. This work will lessen the chance of complete failure of the root systems during high flows, and the subsequent risk of clogging of the channel with this large wood.

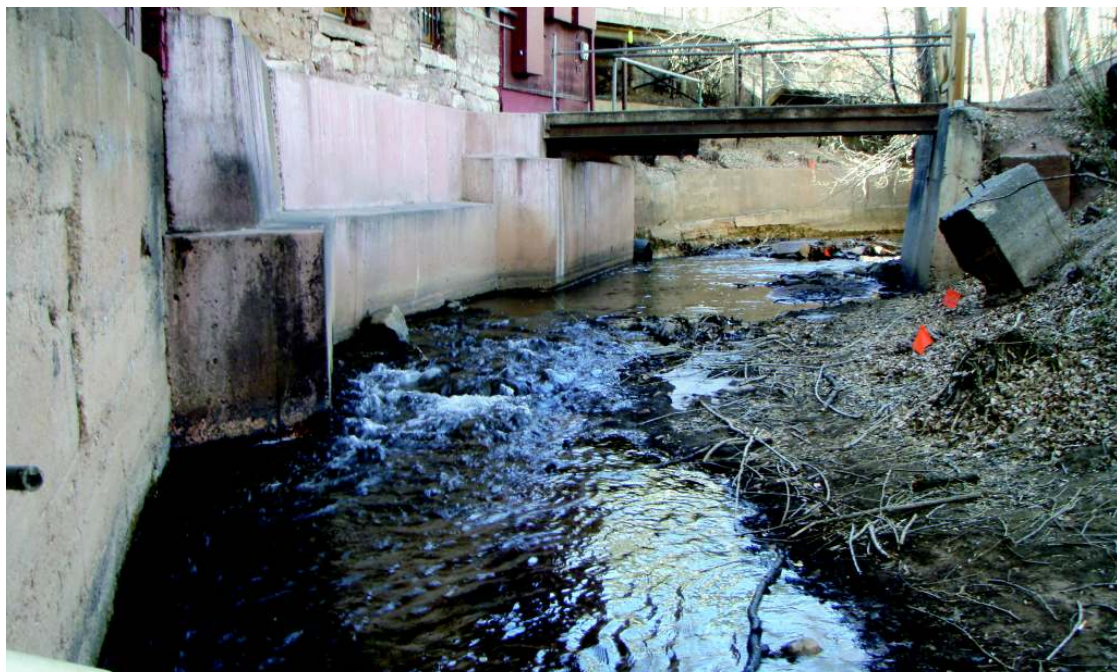
The drop structure at Pool 13 may present a barrier to trout migration through the reach. This structure consists of a metal plate placed diagonally across the stream channel, with the right end embedded into a concrete retaining wall and the downstream left side firmly embedded into the stream bank. A demolition saw will be used to cut a 16” wide by 8” deep notch in the plate to create a lower hydraulic jump between the pool downstream and the pool upstream of this feature, facilitating migration upstream. While it may be preferable to completely remove this feature, we are concerned that a head-cut could migrate up through this segment of the reach, with undesirable consequences to the relatively good quality pools immediately upstream. Removing even a portion of this drop structure could increase the risk of head-cutting, therefore it is recommended that another boulder cross-vane be installed at the transition between Pool 14 and Riffle 18 to eliminate this risk. This boulder cross vane will be configured to relieve shear forces on the right bank retaining wall, where a back eddy is undermining the foundation of the wall. The wall foundation will be protected by 24”- 30” rip-rap boulders where it has failed, immediately below a storm water culvert.

Photo 19: Fountain Creek adjacent to the Stage Coach Inn, looking upstream.

Pocket water cover in Riffles 19, 20 and 21 will be increased and enhanced using the same techniques employed downstream; adjusting existing boulders as necessary and installing up to ten boulder micro-vortex structures. Two boulder rock vanes will be installed along the foundation wall of the Stage Coach Inn, where a lateral scour pool has begun to form immediately adjacent to the foundation footings. These boulder vanes will reduce shear forces along the foundation wall during high flows, as well as provide velocity shelter and fish viewing opportunities for guests dining on the deck of the restaurant immediately above this pool.
